# Access Compliance Report Public Rights-of-Way (Curb Ramps)

Main Street: ROOSEVELT\_AVE Cross Street: VAN\_BUREN\_ST Location: SE

ADA ID: RPRK211001143712 Ramp Type: Type 1 - Perpendicular Diagonal Initial Pass/Fail: Fail Overall Compliance: No Severity Score: 30

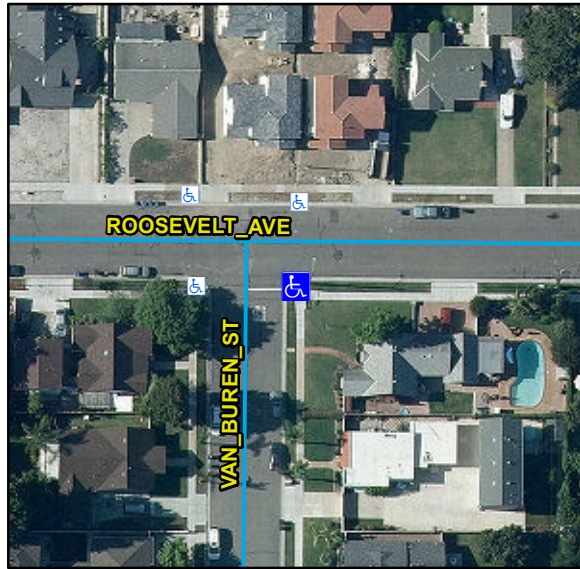
| Compliance | Description | Data | Compliance | Description | Data |
|---|---|---|---|---|---|
| No | Ramp Cross Slope (%) | 9.9 | N/A | Flare Traversable LT | N/A |

Remove & Replace Curb Ramp With Two New Directional Ramps or Equivalent.

R304.2.2, R304.5.3, STD 1115
