# Access Compliance Report Public Rights-of-Way (Curb Ramps)

| Main Street: ROOSEVELT_AVE | | Cross Street: JACKSON_ST | | Location: | SE |
| ADA ID: RPRK211001144300 | Ramp Type:Type 1 - Perpendicular Diagonal Initial Pass/Fail: Fail | | Overall Compliance: No | Severity Score: | 30 |

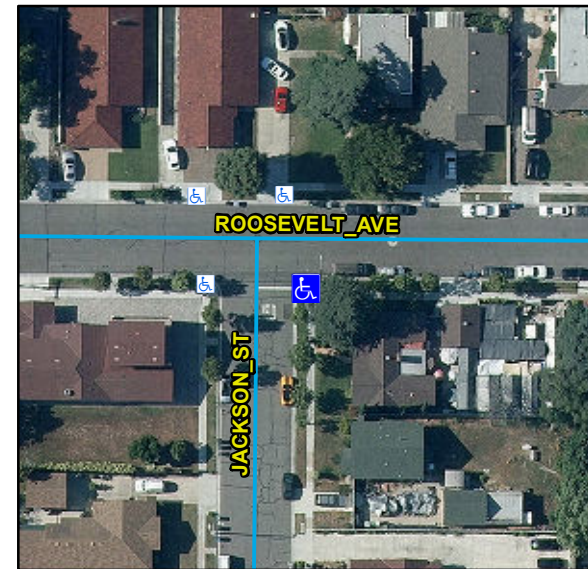
**R304.2.2, R304.5.3, STD 1115**

| Compliance | Description | Data | Compliance | Description | Data |
|---|---|---|---|---|---|
| No | Ramp Cross Slope (%) | 11.9 | N/A | Flare Traversable LT | N/A |

**Remove & Replace Curb Ramp With Two New Directional Ramps or Equivalent.**
