# Access Compliance Report Public Rights-of-Way (Curb Ramps)

Main Street: JACKSON\_ST Cross Street: ROOSEVELT\_AVE Location: SW

ADA ID: RPRK211001144540 Ramp Type: Type 1 - Perpendicular Diagonal Initial Pass/Fail: Fail Overall Compliance: No Severity Score: 19

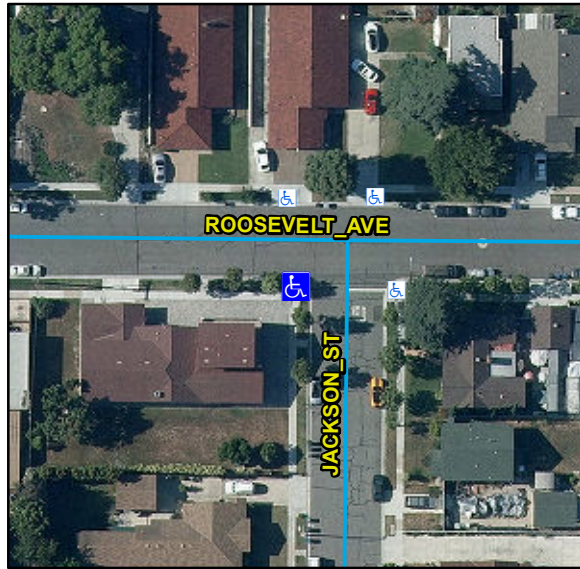
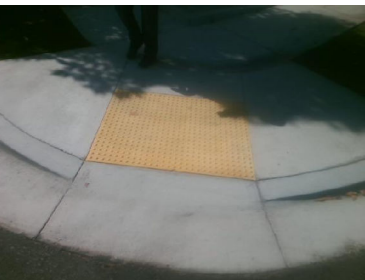
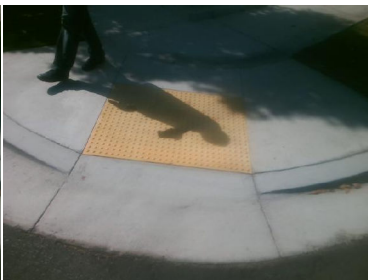
| Compliance | Description | Data | Compliance | Description | Data |
|---|---|---|---|---|---|
| No | Ramp Width (in) | 47 | | | N/A |
| No | Ramp Run Slope (%) | 10.1 | N/A | Flare Slope LT (%) | N/A |

**Remove & Replace Curb Ramp With Two New Directional Ramps or Equivalent.**

**R304.5.1, R304.2.2, STD 1115**
