# Access Compliance Report Public Rights-of-Way (Curb Ramps)

Main Street: ROOSEVELT\_AVE Cross Street: ADAMS\_ST Location: SE

ADA ID: RPRK211001144800 Ramp Type: Type 1 - Perpendicular Diagonal Initial Pass/Fail: Fail Overall Compliance: No Severity Score: 16

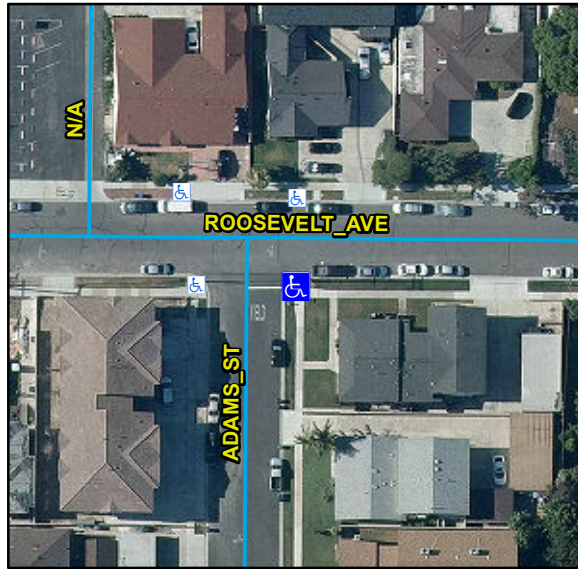
| Compliance | Description | Data | Compliance | Description | Data |
|---|---|---|---|---|---|
| No | Ramp Run Slope (%) | 11.5 | N/A | Flare Slope LT (%) | N/A |
| No | Ramp Cross Slope (%) | 2.8 | N/A | Flare Traversable LT | N/A |

Remove & Replace Curb Ramp With Two New Directional Ramps or Equivalent.
