# Access Compliance Report Public Rights-of-Way (Curb Ramps)

Main Street: ADAMS\_ST Cross Street: ROOSEVELT\_AVE Location: SW

ADA ID: RPRK211001145218 Ramp Type: Type 1 - Perpendicular Diagonal Initial Pass/Fail: Fail Overall Compliance: No Severity Score: 30

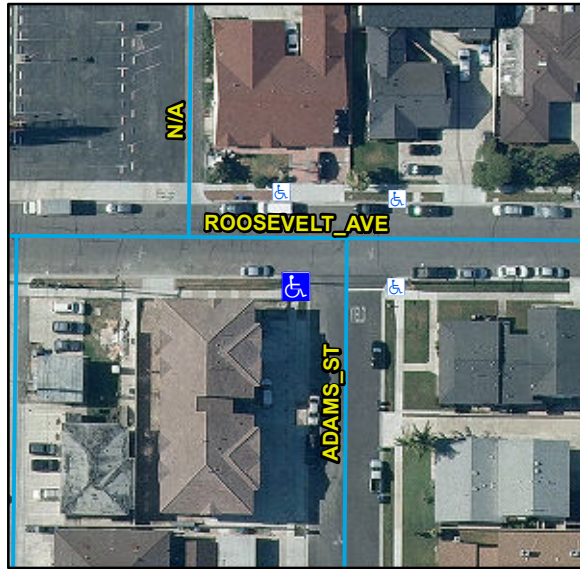
| Compliance | Description | Data | Compliance | Description | Data |
|---|---|---|---|---|---|
| No | Ramp Cross Slope (%) | 9.2 | N/A | Flare Traversable LT | N/A |

**Remove & Replace Curb Ramp With Two New Directional Ramps or Equivalent.**

**R304.2.2, R304.5.3, STD 1115**
