# Access Compliance Report Public Rights-of-Way (Curb Ramps)

Main Street: ROOSEVELT\_AVE Cross Street: BEACH\_BLVD Location: SE

ADA ID: RPRK211001145621 Ramp Type: Type 1 - Perpendicular Diagonal Initial Pass/Fail: Pass Overall Compliance: No Severity Score: 20

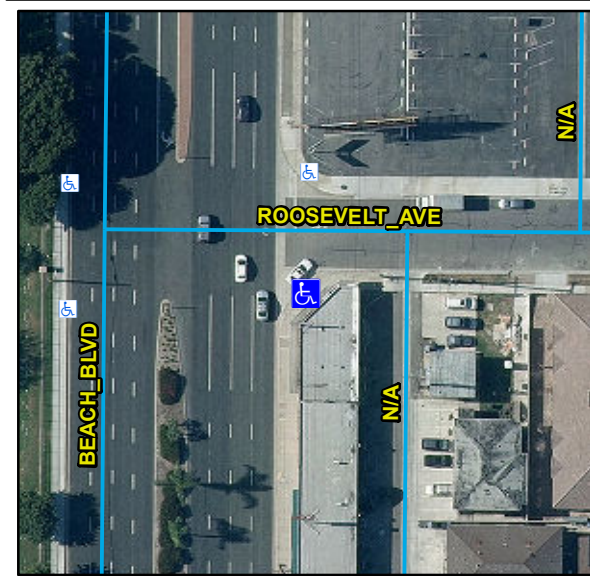
| Compliance | Description | Data | Compliance | Description | Data |
|---|---|---|---|---|---|
| No | Landing Width (in) | N/A | Yes | Flare Slope RT (%) | 7.2 |
| No | Landing Run Slope (%) | N/A | N/A | Flare Traversable RT | Yes |
| No | Landing Cross Slope (%) | N/A | No | DWS Provided | No |

Possible Solutions:  
**Remove & Replace Curb Ramp With Two New Directional Ramps or Equivalent.**

OC Std/PROW:  
**R304.2.1, R304.2.2-Perp, R304.3.2-Para, R304.5.3, R305, STD 1115**

Total Cost: \$ 6160

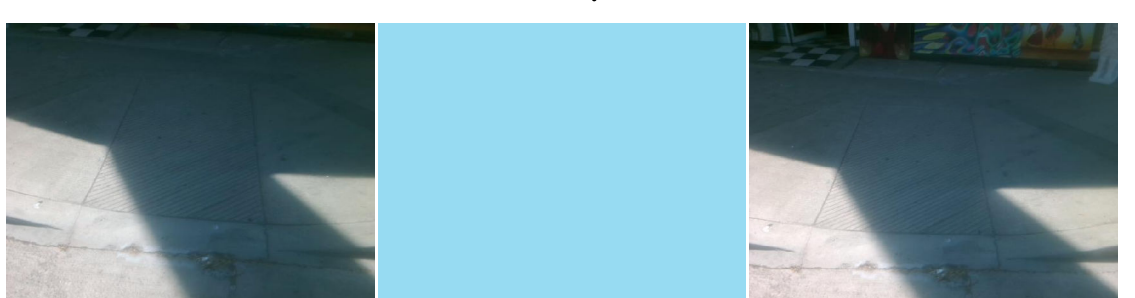
| Compliance | Description | Data | Compliance | Description | Data |
| N/A | Ramp Length (in) | 120 | N/A | Flare Type LT | |
| Yes | Ramp Width (in) | 48 | | | Sloped |
| Yes | Ramp Run Slope (%) | 7.2 | Yes | Flare Slope LT (%) | 5.6 |
| Yes | Ramp Cross Slope (%) | 0.3 | N/A | Flare Traversable LT | Yes |
