# Access Compliance Report Public Rights-of-Way (Curb Ramps)

Main Street: BEACH\_BLVD Cross Street: ROOSEVELT\_AVE Location: NE

ADA ID: RPRK211001145945 Ramp Type: Type 1 - Perpendicular Diagonal Initial Pass/Fail: Fail Overall Compliance: No Severity Score: 15

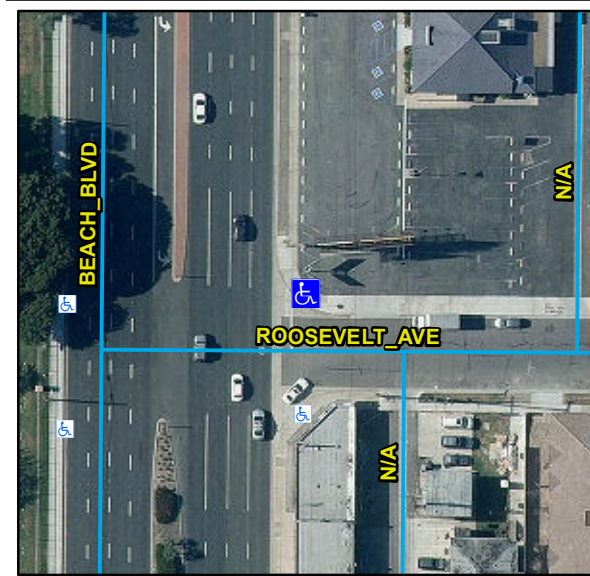
| Compliance | Description | Data | Compliance | Description | Data |
|---|---|---|---|---|---|
| No | Ramp Cross Slope (%) | 6.7 | N/A | Flare Traversable LT | N/A |

Possible Solutions:  
**Remove & Replace Curb Ramp With Two New Directional Ramps or Equivalent.**

OC Std/PROW:  
**R304.2.2, R304.5.3, STD 1115**
