# Access Compliance Report Public Rights-of-Way (Curb Ramps)

Main Street: MONROE\_ST Cross Street: ROOSEVELT\_AVE Location: SW

ADA ID: RPRK211001150954 Ramp Type: Type 1 - Perpendicular Diagonal Initial Pass/Fail: Fail Overall Compliance: No Severity Score: 15

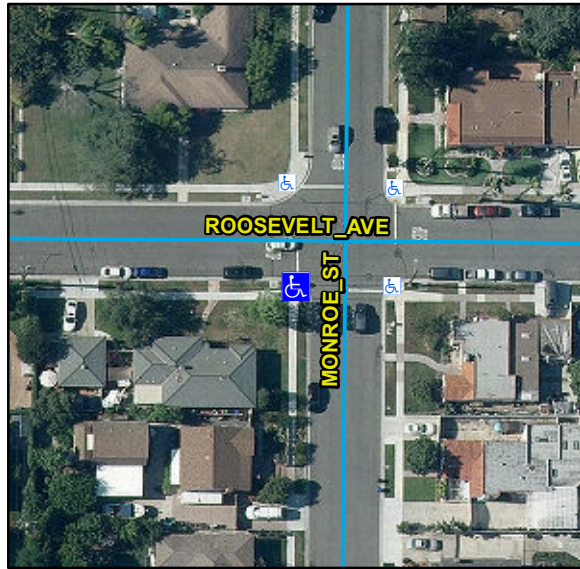
| Compliance | Description | Data | Compliance | Description | Data |
|---|---|---|---|---|---|
| No | Ramp Cross Slope (%) | 6 | N/A | Flare Traversable LT | N/A |

Remove & Replace Curb Ramp With Two New Directional Ramps or Equivalent.

R304.5.3, STD 1115
