# Access Compliance Report Public Rights-of-Way (Curb Ramps)

| Main Street: ROOSEVELT_AVE | | Cross Street: MONROE_ST | | Location: | SE |
| ADA ID: RPRK211001151223 | Ramp Type:Type 1 - Perpendicular Diagonal Initial Pass/Fail: Fail | | Overall Compliance: No | Severity Score: | 30 |

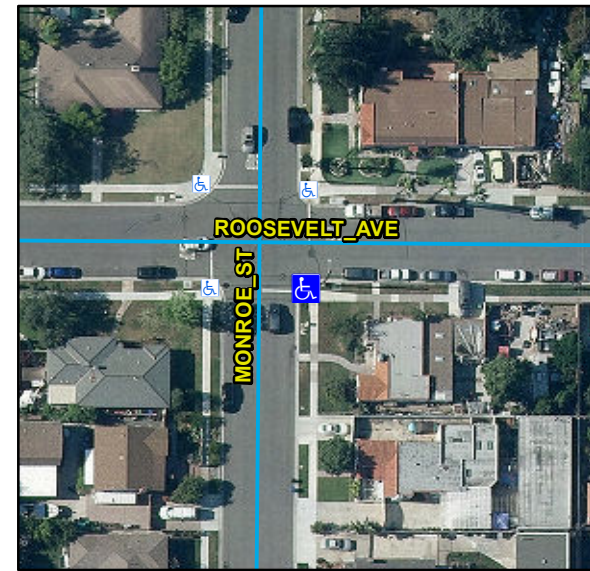
| Compliance | Description | Data | Compliance | Description | Data |
|---|---|---|---|---|---|
| No | Ramp Cross Slope (%) | 10.9 | N/A | Flare Traversable LT | N/A |

| Remove & Replace Curb Ramp With Two New Directional Ramps or Equivalent. | |
