# Access Compliance Report Public Rights-of-Way (Curb Ramps)

Main Street: MONROE\_ST Cross Street: ROOSEVELT\_AVE Location: NE

ADA ID: RPRK211001151404 Ramp Type: Type 1 - Perpendicular Diagonal Initial Pass/Fail: Fail Overall Compliance: No Severity Score: 15

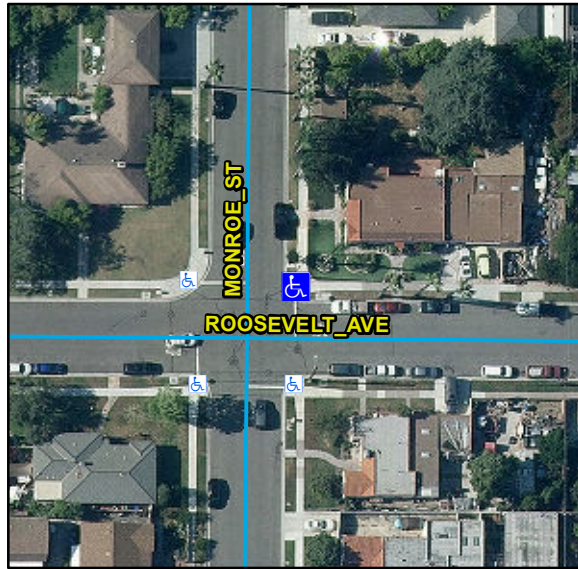
| Compliance | Description | Data | Compliance | Description | Data |
|---|---|---|---|---|---|
| No | Ramp Cross Slope (%) | 5.6 | N/A | Flare Traversable LT | N/A |

**Remove & Replace Curb Ramp With Two New Directional Ramps or Equivalent.**

**R304.5.3, STD 1115**
