# Access Compliance Report Public Rights-of-Way (Curb Ramps)

| Main Street: ROOSEVELT_AVE | | Cross Street: MONROE_ST | | Location: | NW |
| ADA ID: RPRK211001151623 | Ramp Type:Type 1 - Perpendicular Diagonal Initial Pass/Fail: Pass | | Overall Compliance: No | Severity Score: | 12 |

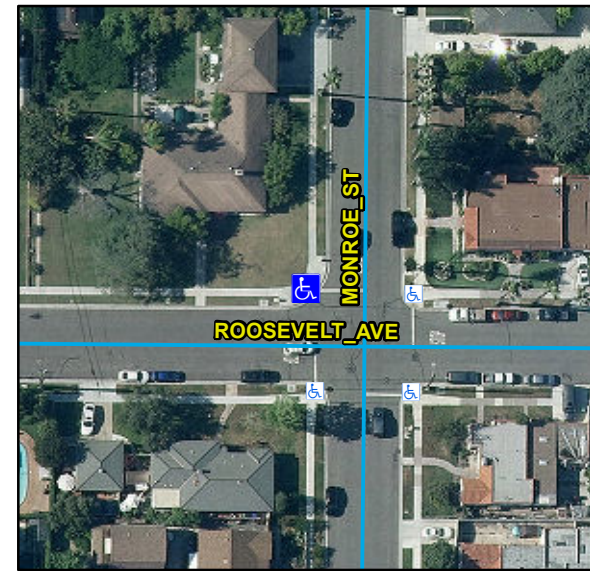
| Compliance | Description | Data | Compliance | Description | Data |
|---|---|---|---|---|---|
| No | Ramp Cross Slope (%) | 2.5 | N/A | Flare Traversable LT | Yes |
| No | Landing Width (in) | N/A | Yes | Flare Slope RT (%) | 4.4 |
| No | Landing Run Slope (%) | N/A | N/A | Flare Traversable RT | Yes |
| No | Landing Cross Slope (%) | N/A | Yes | DWS Provided | Yes |

**Remove & Replace Curb Ramp With Two New Directional Ramps or Equivalent.**

**R304.5.3, R304.2.1, R304.2.2-Perp, R304.3.2-Para, STD 1115**

Total Cost: \$ 6160
