# Access Compliance Report Public Rights-of-Way (Curb Ramps)

Main Street: MADISON\_AVE Cross Street: BEACH\_BLV Location: SE

ADA ID: RPRK211001182412 Ramp Type: Type 1 - Perpendicular Diagonal Initial Pass/Fail: Fail Overall Compliance: No Severity Score: 20

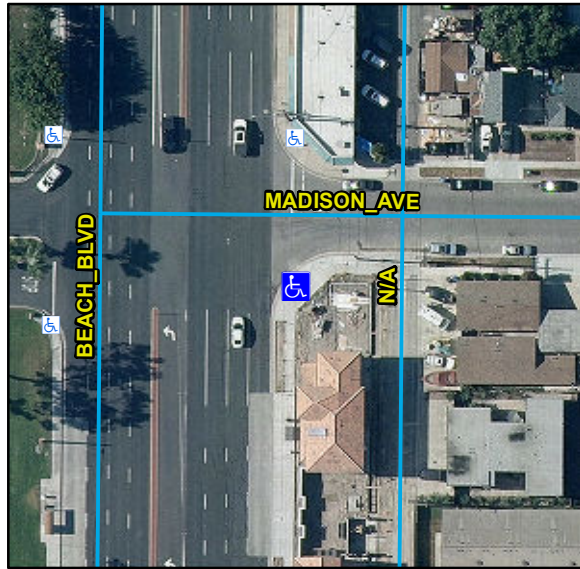
| Compliance | Description | Data | Compliance | Description | Data |
|---|---|---|---|---|---|
| No | Ramp Width (in) | 36 | | | N/A |
| No | Ramp Run Slope (%) | 11.7 | N/A | Flare Slope LT (%) | N/A |
| No | Ramp Cross Slope (%) | 2.2 | N/A | Flare Traversable LT | N/A |

**Remove & Replace Curb Ramp With Two New Directional Ramps or Equivalent.**

**R304.2.2, R304.5.1, R304.5.3, STD 1115**
