# Access Compliance Report Public Rights-of-Way (Curb Ramps)

Main Street: BEACH\_BLVD Cross Street: MADISON\_AVE Location: NE

ADA ID: RPRK211001183028 Ramp Type: Type 1 - Perpendicular Diagonal Initial Pass/Fail: Fail Overall Compliance: No Severity Score: 34

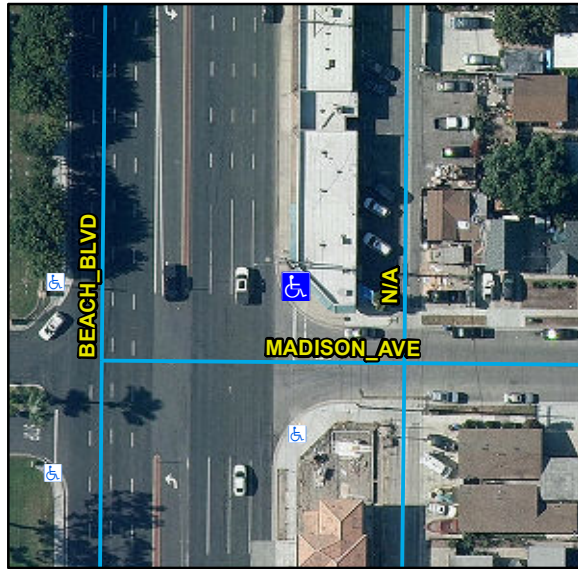
| Compliance | Description | Data | Compliance | Description | Data |
|---|---|---|---|---|---|
| No | Ramp Width (in) | 36 | | | N/A |
| No | Ramp Run Slope (%) | 13.3 | N/A | Flare Slope LT (%) | N/A |

Remove & Replace Curb Ramp With Two New Directional Ramps or Equivalent.

R304.5.1, R304.2.2, STD 1115

Total Cost: \$ 6160
