# Access Compliance Report Public Rights-of-Way (Curb Ramps)

Main Street: MADISON\_AVE Cross Street: ADAMS\_ST Location: NW

ADA ID: RPRK211001183639 Ramp Type: Type 1 - Perpendicular Diagonal Initial Pass/Fail: Fail Overall Compliance: No Severity Score: 34

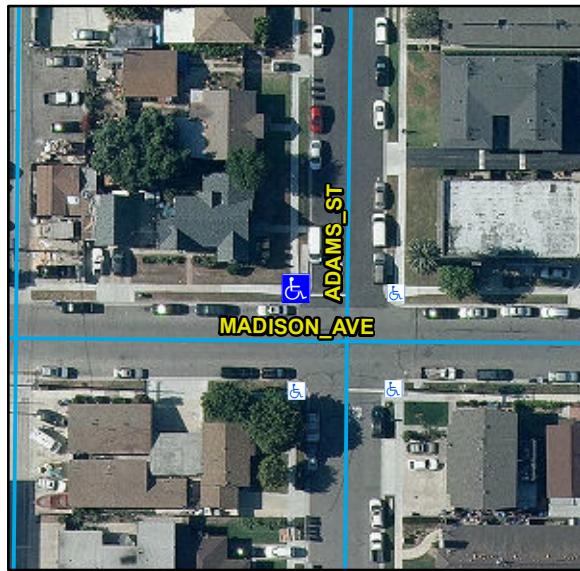
| Compliance | Description | Data | Compliance | Description | Data |
|---|---|---|---|---|---|
| No | Ramp Width (in) | 36 | | | N/A |
| No | Ramp Run Slope (%) | 13.2 | N/A | Flare Slope LT (%) | N/A |
| N/A | Gutter Ponding | N/A | No | Curb Slope | 14.1 |

Remove & Replace Curb Ramp With Two New Directional Ramps or Equivalent.

R304.2.2, R304.5.1, STD 1115
