# Access Compliance Report Public Rights-of-Way (Curb Ramps)

Main Street: ADAMS\_ST Cross Street: MADISON\_AVE Location: SW

ADA ID: RPRK211001184229 Ramp Type: Type 1 - Perpendicular Diagonal Initial Pass/Fail: Fail Overall Compliance: No Severity Score: 35

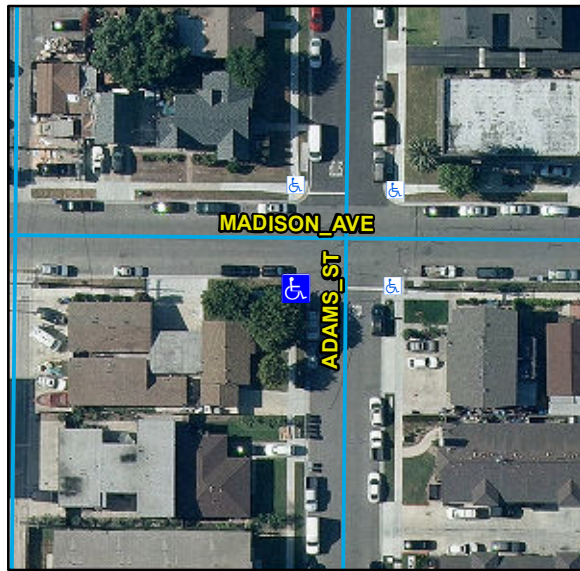
| Compliance | Description | Data | Compliance | Description | Data |
|---|---|---|---|---|---|
| N/A | Ramp Length (in) | 111 | N/A | Flare Type LT | |
| No | Ramp Width (in) | 36 | | | N/A |
| No | Ramp Run Slope (%) | 12.3 | N/A | Flare Slope LT (%) | N/A |
| No | Ramp Cross Slope (%) | 2.7 | N/A | Flare Traversable LT | N/A |

**Remove & Replace Curb Ramp With Two New Directional Ramps or Equivalent.**

**R304.2.2, R304.5.1, R304.5.3, STD 1115**
