# Access Compliance Report

## Public Rights-of-Way

### (Curb Ramps)

Main Street: MADISON\_AVE Cross Street: ADAMS\_ST Location: SE

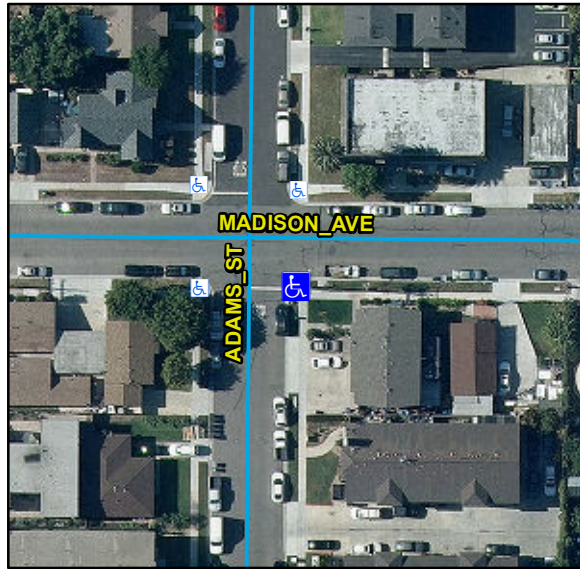
ADA ID: RPRK211001184714 Ramp Type: Type 1 - Perpendicular Diagonal Initial Pass/Fail: Fail Overall Compliance: No Severity Score: 19

| Compliance | Description | Data | Compliance | Description | Data |
|---|---|---|---|---|---|
| No | Ramp Width (in) | 36 | | | N/A |
| No | Ramp Run Slope (%) | 11 | N/A | Flare Slope LT (%) | N/A |

**Remove & Replace Curb Ramp With Two New Directional Ramps or Equivalent.**

**R304.2.2, R304.5.1, STD 1115**
