# Access Compliance Report Public Rights-of-Way (Curb Ramps)

Main Street: ADAMS\_ST Cross Street: MADISON\_AVE Location: NE

ADA ID: RPRK211001185200 Ramp Type: Type 1 - Perpendicular Diagonal Initial Pass/Fail: Fail Overall Compliance: No Severity Score: 20

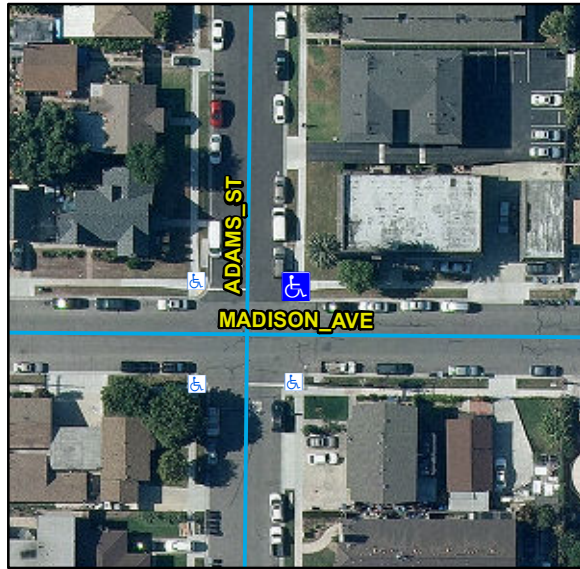
| Compliance | Description | Data | Compliance | Description | Data |
|---|---|---|---|---|---|
| No | Ramp Width (in) | 36 | | | N/A |
| No | Ramp Run Slope (%) | 10.6 | N/A | Flare Slope LT (%) | N/A |
| No | Ramp Cross Slope (%) | 2.4 | N/A | Flare Traversable LT | N/A |

Remove & Replace Curb Ramp With Two New Directional Ramps or Equivalent.
