# Access Compliance Report Public Rights-of-Way (Curb Ramps)

Main Street: JACKSON\_ST Cross Street: MADISON\_AVE Location: SW

ADA ID: RPRK211001190007 Ramp Type: Type 1 - Perpendicular Diagonal Initial Pass/Fail: Fail Overall Compliance: No Severity Score: 19

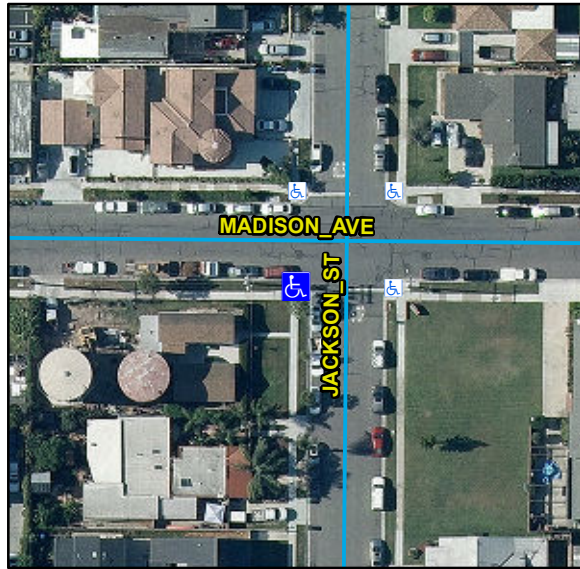
| Compliance | Description | Data | Compliance | Description | Data |
|---|---|---|---|---|---|
| No | Ramp Width (in) | 36 | | | N/A |
| No | Ramp Run Slope (%) | 11.1 | N/A | Flare Slope LT (%) | N/A |

Remove & Replace Curb Ramp With Two New Directional Ramps or Equivalent.

R304.2.2, R304.5.1, STD 1115
