# Access Compliance Report Public Rights-of-Way (Curb Ramps)

Main Street: MADISON\_AVE Cross Street: JACKSON\_ST Location: NW

ADA ID: RPRK211001190622 Ramp Type: Type 1 - Perpendicular Diagonal Initial Pass/Fail: Fail Overall Compliance: No Severity Score: 19

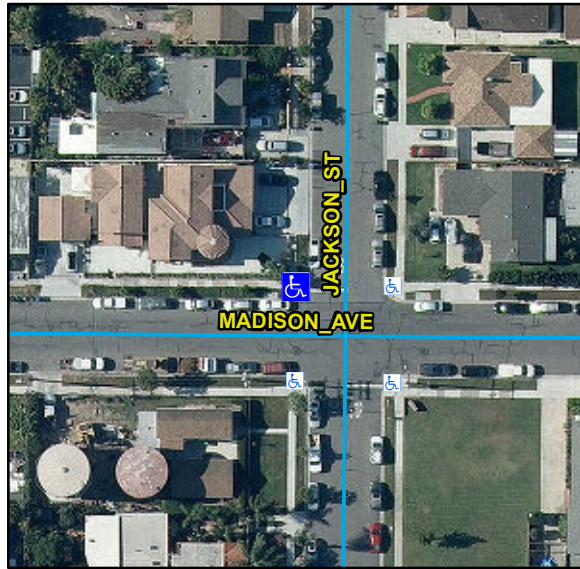
| Compliance | Description | Data | Compliance | Description | Data |
|---|---|---|---|---|---|
| No | Ramp Width (in) | 36 | | | N/A |
| No | Ramp Run Slope (%) | 10.4 | N/A | Flare Slope LT (%) | N/A |

**Remove & Replace Curb Ramp With Two New Directional Ramps or Equivalent.**

**R304.2.2, R304.5.1, STD 1115**
