# Access Compliance Report Public Rights-of-Way (Curb Ramps)

Main Street: JACKSON\_ST Cross Street: MADISON\_AVE Location: NE

ADA ID: RPRK211001191438 Ramp Type: Type 1 - Perpendicular Diagonal Initial Pass/Fail: Fail Overall Compliance: No Severity Score: 4

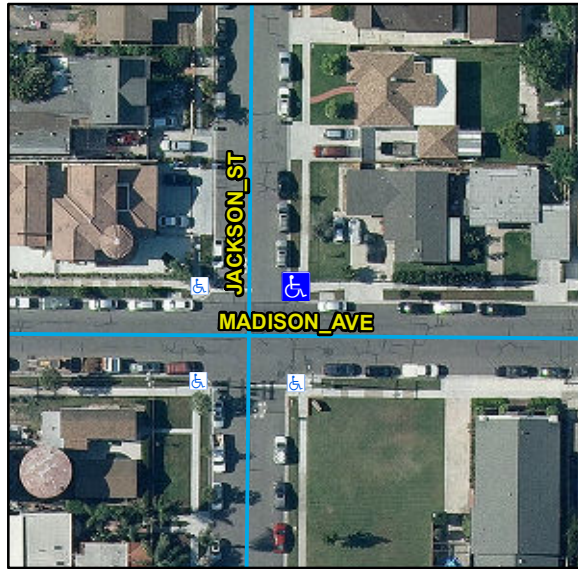
| Compliance | Description | Data | Compliance | Description | Data |
|---|---|---|---|---|---|
| N/A | Ramp Length (in) | 101 | N/A | Flare Type LT | |
| No | Ramp Width (in) | 36 | | | N/A |

**Remove & Replace Curb Ramp With Two New Directional Ramps or Equivalent.**

**R304.5.1, STD 1115**
