# Access Compliance Report Public Rights-of-Way (Curb Ramps)

Main Street: MADISON\_AVE Cross Street: JACKSON\_ST Location: SE

ADA ID: RPRK211001192407 Ramp Type: Type 1 - Perpendicular Diagonal Initial Pass/Fail: Fail Overall Compliance: No Severity Score: 20

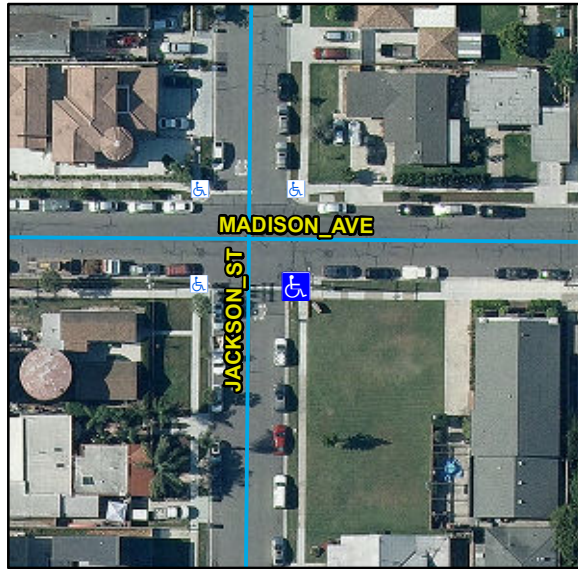
| Compliance | Description | Data | Compliance | Description | Data |
|---|---|---|---|---|---|
| No | Ramp Width (in) | 36 | | | N/A |
| No | Ramp Run Slope (%) | 11.3 | N/A | Flare Slope LT (%) | N/A |
| No | Ramp Cross Slope (%) | 3.9 | N/A | Flare Traversable LT | N/A |

**Remove & Replace Curb Ramp With Two New Directional Ramps or Equivalent.**

**R304.2.2, R304.5.1, R304.5.3, STD 1115**
