# Access Compliance Report Public Rights-of-Way (Curb Ramps)

Main Street: MADISON\_AVE Cross Street: VAN\_BUREN\_ST Location: SE

ADA ID: RPRK211001194534 Ramp Type: Type 1 - Perpendicular Diagonal Initial Pass/Fail: Fail Overall Compliance: No Severity Score: 20

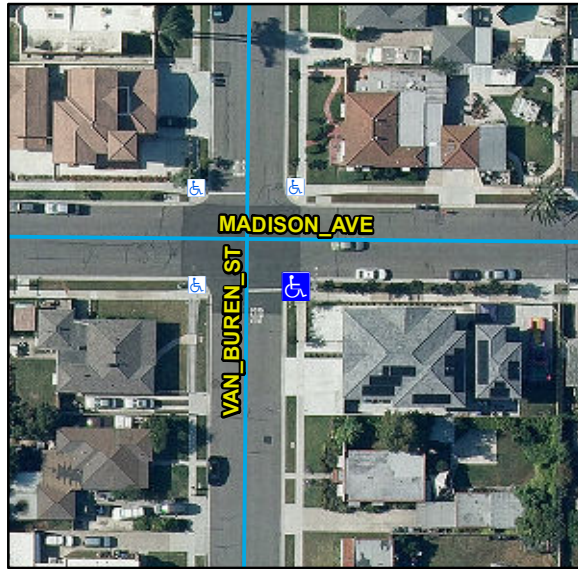
| Compliance | Description | Data | Compliance | Description | Data |
|---|---|---|---|---|---|
| No | Ramp Width (in) | 36 | | | N/A |
| No | Ramp Run Slope (%) | 10.7 | N/A | Flare Slope LT (%) | N/A |
| No | Ramp Cross Slope (%) | 2.1 | N/A | Flare Traversable LT | N/A |

**Remove & Replace Curb Ramp With Two New Directional Ramps or Equivalent.**

**R304.2.2, R304.5.1, R304.5.3, STD 1115**
