# Access Compliance Report Public Rights-of-Way (Curb Ramps)

Main Street: MONROE\_ST Cross Street: MADISON\_AVE Location: SW

ADA ID: RPRK211004110000 Ramp Type: Type 1 - Perpendicular Diagonal Initial Pass/Fail: Fail Overall Compliance: No Severity Score: 19

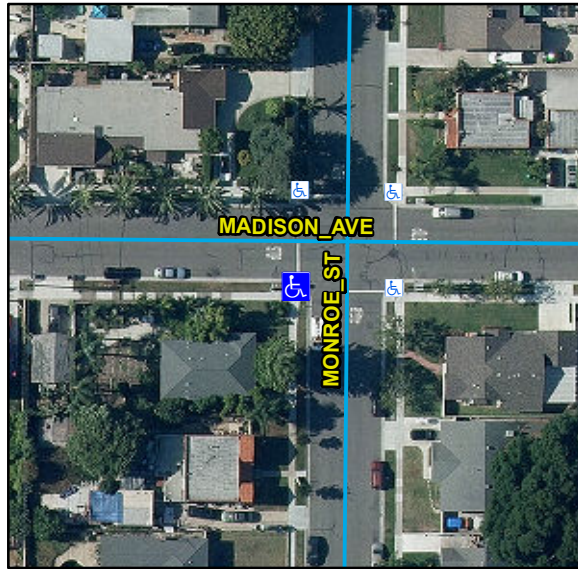
| Compliance | Description | Data | Compliance | Description | Data |
|---|---|---|---|---|---|
| No | Ramp Width (in) | 36 | | | N/A |
| No | Ramp Run Slope (%) | 12 | N/A | Flare Slope LT (%) | N/A |

Remove & Replace Curb Ramp With Two New Directional Ramps or Equivalent.

R304.5.1, R304.2.2, STD 1115

Total Cost: \$ 6160
