# Access Compliance Report Public Rights-of-Way (Curb Ramps)

Main Street: MADISON\_AVE Cross Street: MONROE\_ST Location: NW

ADA ID: RPRK211004110948 Ramp Type: Type 1 - Perpendicular Diagonal Initial Pass/Fail: Fail Overall Compliance: No Severity Score: 20

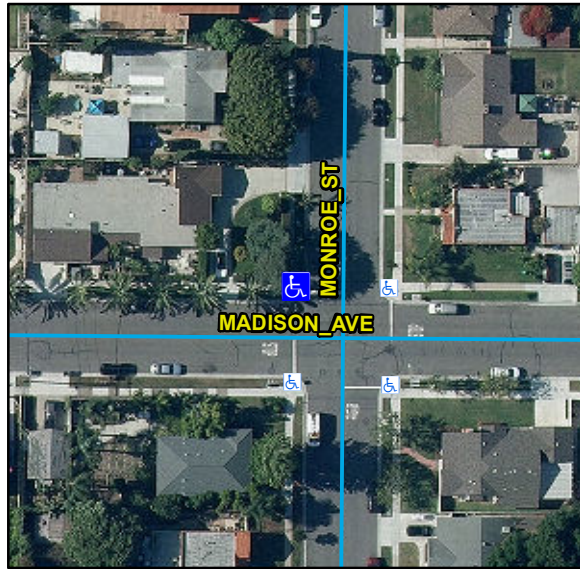
| Compliance | Description | Data | Compliance | Description | Data |
|---|---|---|---|---|---|
| No | Ramp Width (in) | 36 | | | N/A |
| No | Ramp Run Slope (%) | 10.6 | N/A | Flare Slope LT (%) | N/A |
| No | Ramp Cross Slope (%) | 2.7 | N/A | Flare Traversable LT | N/A |

**Remove & Replace Curb Ramp With Two New Directional Ramps or Equivalent.**

**R304.5.1, R304.2.2, R304.5.3, STD 1115**
