# Access Compliance Report Public Rights-of-Way (Curb Ramps)

Main Street: MONROE\_ST Cross Street: MADISON\_AVE Location: NE

ADA ID: RPRK211004111540 Ramp Type: Type 1 - Perpendicular Diagonal Initial Pass/Fail: Fail Overall Compliance: No Severity Score: 19

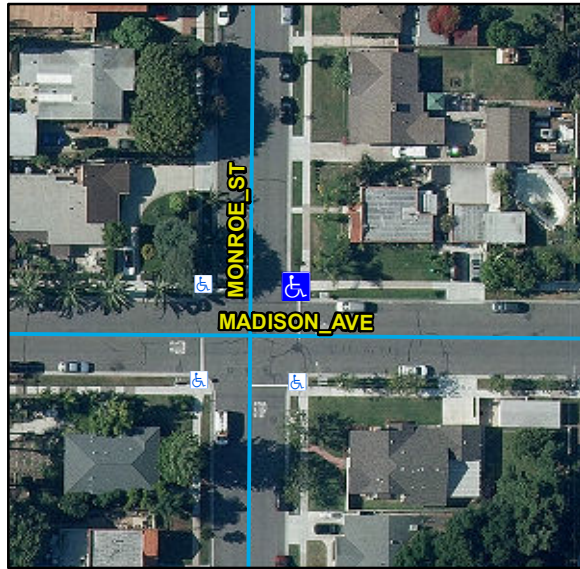
| Compliance | Description | Data | Compliance | Description | Data |
|---|---|---|---|---|---|
| No | Ramp Width (in) | 36 | | | N/A |
| No | Ramp Run Slope (%) | 10.9 | N/A | Flare Slope LT (%) | N/A |

**Remove & Replace Curb Ramp With Two New Directional Ramps or Equivalent.**

**R304.5.1, R304.2.2, STD 1115**
