# Access Compliance Report Public Rights-of-Way (Curb Ramps)

Main Street: MADISON\_AVE Cross Street: MONROE\_ST Location: SE

ADA ID: RPRK211004112057 Ramp Type: Type 1 - Perpendicular Diagonal Initial Pass/Fail: Fail Overall Compliance: No Severity Score: 19

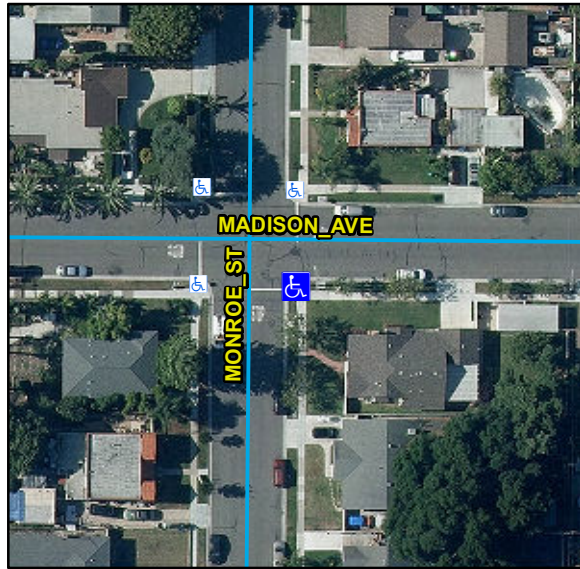
| Compliance | Description | Data | Compliance | Description | Data |
|---|---|---|---|---|---|
| No | Ramp Width (in) | 36 | | | N/A |
| No | Ramp Run Slope (%) | 11.4 | N/A | Flare Slope LT (%) | N/A |

**Remove & Replace Curb Ramp With Two New Directional Ramps or Equivalent.**

**R304.5.1, R304.2.2, STD 1115**
