# Access Compliance Report Public Rights-of-Way (Curb Ramps)

Main Street: JEFFERSON\_ST Cross Street: MADISON\_AVE Location: SW

ADA ID: RPRK211004112745 Ramp Type: Type 1 - Perpendicular Diagonal Initial Pass/Fail: Fail Overall Compliance: No Severity Score: 20

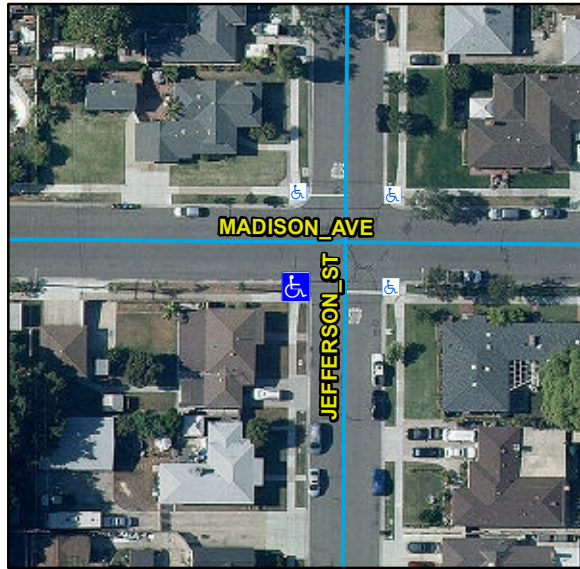
| Compliance | Description | Data | Compliance | Description | Data |
|---|---|---|---|---|---|
| No | Ramp Width (in) | 36 | | | N/A |
| No | Ramp Run Slope (%) | 11.1 | N/A | Flare Slope LT (%) | N/A |
| No | Ramp Cross Slope (%) | 4 | N/A | Flare Traversable LT | N/A |

Remove & Replace Curb Ramp With Two New Directional Ramps or Equivalent.

R304.2.2, R304.5.1, R304.5.3, STD 1115
