# Access Compliance Report Public Rights-of-Way (Curb Ramps)

Main Street: MADISON\_AVE Cross Street: JEFFERSON\_ST Location: NW

ADA ID: RPRK211004113200 Ramp Type: Type 1 - Perpendicular Diagonal Initial Pass/Fail: Fail Overall Compliance: No Severity Score: 20

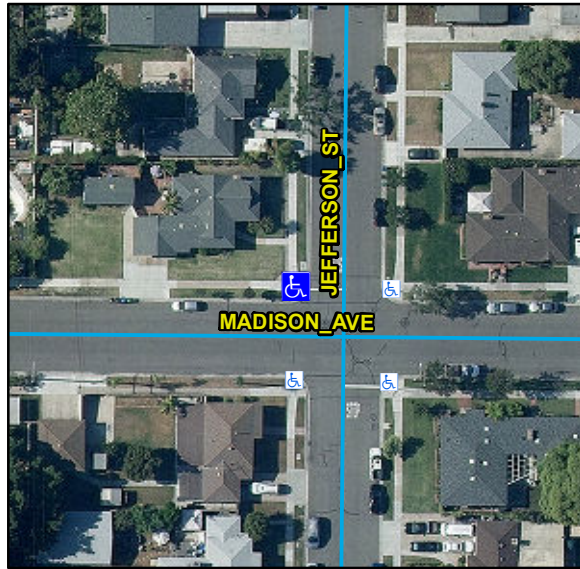
| Compliance | Description | Data | Compliance | Description | Data |
|---|---|---|---|---|---|
| No | Ramp Width (in) | 36 | | | N/A |
| No | Ramp Run Slope (%) | 11.2 | N/A | Flare Slope LT (%) | N/A |
| No | Ramp Cross Slope (%) | 2.1 | N/A | Flare Traversable LT | N/A |

**Remove & Replace Curb Ramp With Two New Directional Ramps or Equivalent.**

**R304.2.2, R304.5.1, R304.5.3, STD 1115**
