# Access Compliance Report Public Rights-of-Way (Curb Ramps)

Main Street: JEFFERSON\_ST Cross Street: MADISON\_AVE Location: NE

ADA ID: RPRK211004120153 Ramp Type:Type 1 - Perpendicular Diagonal Initial Pass/Fail: Pass Overall Compliance: No Severity Score: 10

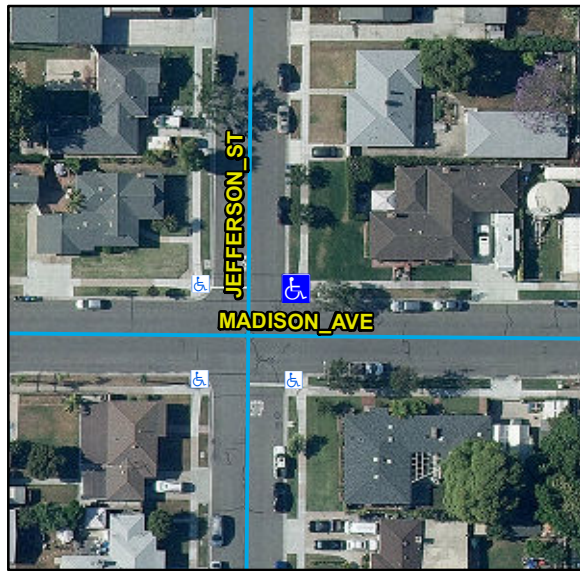
| Compliance | Description | Data | Compliance | Description | Data |
|---|---|---|---|---|---|
| No | Landing Width (in) | N/A | N/A | Flare Slope RT (%) | 0.1 |
| No | Landing Run Slope (%) | N/A | N/A | Flare Traversable RT | No |
| No | Landing Cross Slope (%) | N/A | Yes | DWS Provided | Yes |
| No | Gutter Cross Slope (%) | 3.3 | | | |

Remove & Replace Curb Ramp With Two New Directional Ramps or Equivalent. Remove & Replace Gutter.
