# Access Compliance Report Public Rights-of-Way (Curb Ramps)

Main Street: MADISON\_AVE Cross Street: JEFFERSON\_ST Location: SE

ADA ID: RPRK211004120549 Ramp Type: Type 1 - Perpendicular Diagonal Initial Pass/Fail: Fail Overall Compliance: No Severity Score: 30

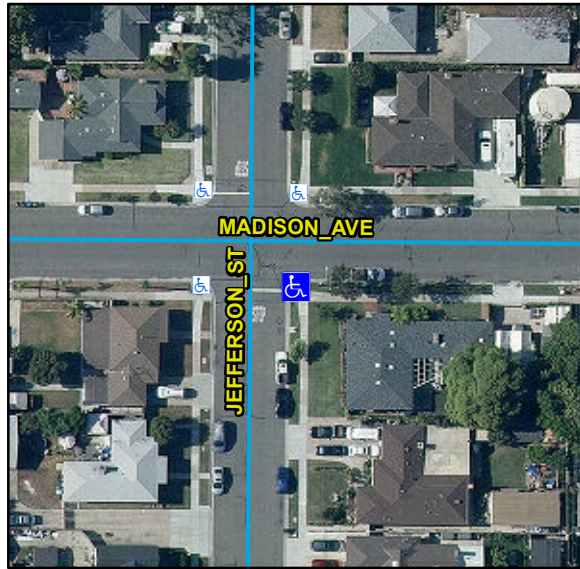
| Compliance | Description | Data | Compliance | Description | Data |
|---|---|---|---|---|---|
| No | Ramp Run Slope (%) | 12.7 | N/A | Flare Slope LT (%) | N/A |

Remove & Replace Curb Ramp With Two New Directional Ramps or Equivalent.

R304.2.2, STD 1115
