# Access Compliance Report Public Rights-of-Way (Curb Ramps)

Main Street: WILSON\_ST Cross Street: MADISON\_AVE Location: SW

ADA ID: RPRK211004120841 Ramp Type: Type 1 - Perpendicular Diagonal Initial Pass/Fail: Fail Overall Compliance: No Severity Score: 30

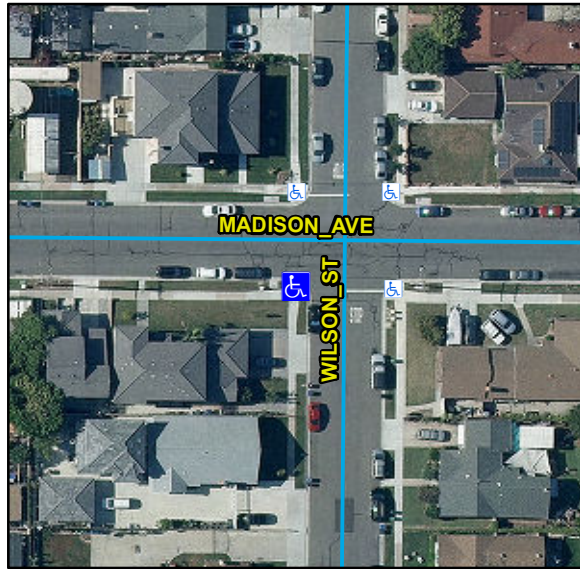
| Compliance | Description | Data | Compliance | Description | Data |
|---|---|---|---|---|---|
| No | Ramp Run Slope (%) | 12.2 | N/A | Flare Slope LT (%) | N/A |

Remove & Replace Curb Ramp With Two New Directional Ramps or Equivalent.

R304.2.2, STD 1115
