# Access Compliance Report Public Rights-of-Way (Curb Ramps)

Main Street: MADISON\_AVE Cross Street: WILSON\_ST Location: SE

ADA ID: RPRK211004121116 Ramp Type: Type 1 - Perpendicular Diagonal Initial Pass/Fail: Fail Overall Compliance: No Severity Score: 15

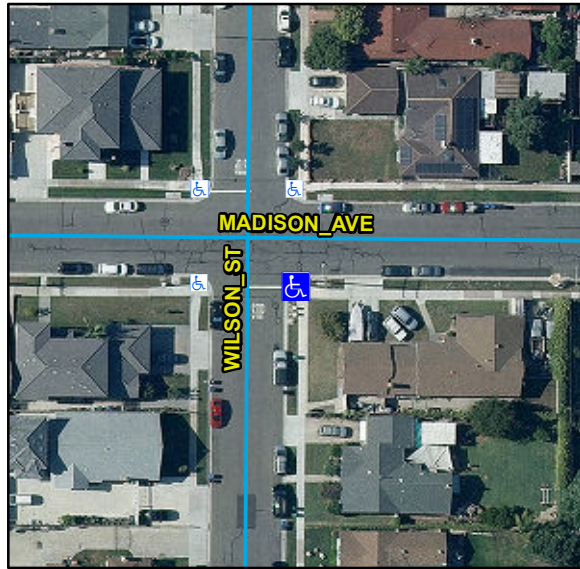
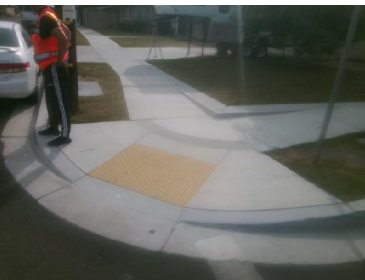
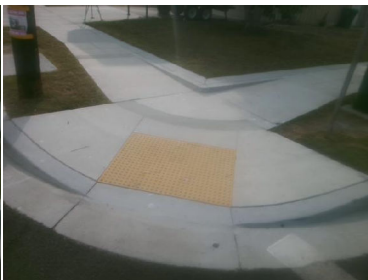
| Compliance | Description | Data | Compliance | Description | Data |
|---|---|---|---|---|---|
| No | Ramp Run Slope (%) | 10.6 | N/A | Flare Slope LT (%) | N/A |

Remove & Replace Curb Ramp With Two New Directional Ramps or Equivalent.

R304.2.2, STD 1115
