# Access Compliance Report Public Rights-of-Way (Curb Ramps)

Main Street: WILSON\_ST Cross Street: MADISON\_AVE Location: NE

ADA ID: RPRK211004121332 Ramp Type: Type 1 - Perpendicular Diagonal Initial Pass/Fail: Fail Overall Compliance: No Severity Score: 15

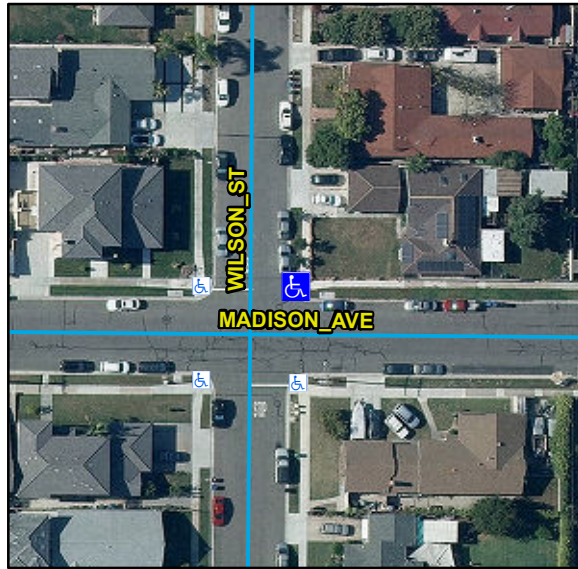
| Compliance | Description | Data | Compliance | Description | Data |
|---|---|---|---|---|---|
| No | Ramp Run Slope (%) | 10.2 | N/A | Flare Slope LT (%) | N/A |
| N/A | Gutter Ponding | N/A | No | Curb Slope | 9.5 |

Remove & Replace Curb Ramp With Two New Directional Ramps or Equivalent.

R304.2.2, STD 1115
