# Access Compliance Report Public Rights-of-Way (Curb Ramps)

Main Street: MADISON\_AVE Cross Street: WILSON\_ST Location: NW

ADA ID: RPRK211004121531 Ramp Type: Type 1 - Perpendicular Diagonal Initial Pass/Fail: Fail Overall Compliance: No Severity Score: 30

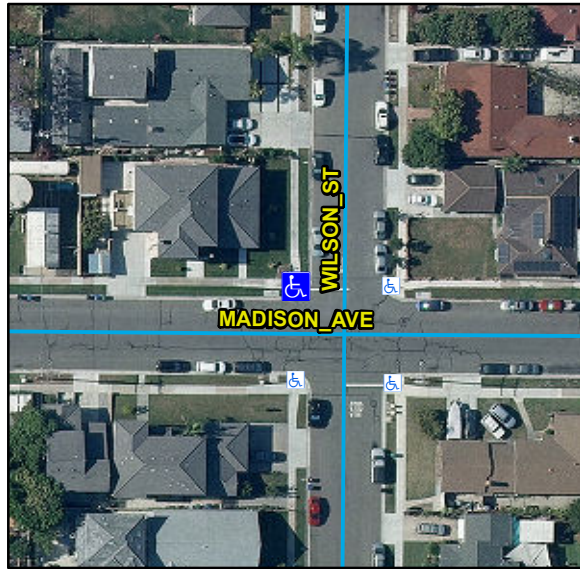
| Compliance | Description | Data | Compliance | Description | Data |
|---|---|---|---|---|---|
| No | Ramp Cross Slope (%) | 11.4 | N/A | Flare Traversable LT | N/A |

Remove & Replace Curb Ramp With Two New Directional Ramps or Equivalent.

R304.2.2, R304.5.3, STD 1115
