# Access Compliance Report Public Rights-of-Way (Curb Ramps)

Main Street: HARPER\_ST Cross Street: MADISON\_AVE Location: SW

ADA ID: RPRK211004121833 Ramp Type: Type 1 - Perpendicular Diagonal Initial Pass/Fail: Fail Overall Compliance: No Severity Score: 20

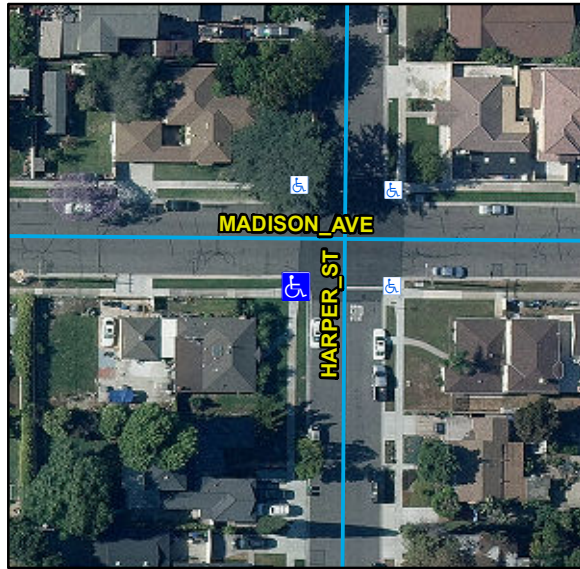
| Compliance | Description | Data | Compliance | Description | Data |
|---|---|---|---|---|---|
| No | Ramp Width (in) | 47 | | | N/A |
| No | Ramp Run Slope (%) | 11.2 | N/A | Flare Slope LT (%) | N/A |
| No | Ramp Cross Slope (%) | 2.1 | N/A | Flare Traversable LT | N/A |

**Remove & Replace Curb Ramp With Two New Directional Ramps or Equivalent.**

**R304.2.2, R304.5.1, R304.5.3, STD 1115**
