# Access Compliance Report Public Rights-of-Way (Curb Ramps)

Main Street: MADISON\_AVE Cross Street: HARPER\_ST Location: SE

ADA ID: RPRK211004122121 Ramp Type: Type 1 - Perpendicular Diagonal Initial Pass/Fail: Fail Overall Compliance: No Severity Score: 30

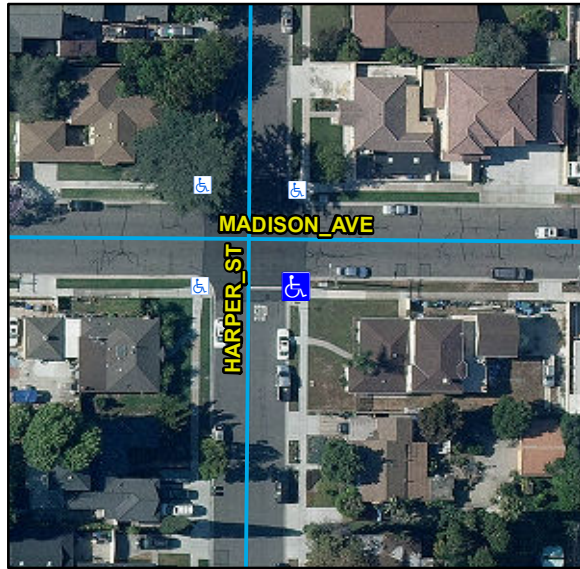
| Compliance | Description | Data | Compliance | Description | Data |
|---|---|---|---|---|---|
| No | Ramp Cross Slope (%) | 10 | N/A | Flare Traversable LT | N/A |

**Remove & Replace Curb Ramp With Two New Directional Ramps or Equivalent.**

**R304.2.2, R304.5.3, STD 1115**
