# Access Compliance Report Public Rights-of-Way (Curb Ramps)

Main Street: MADISON\_AVE Cross Street: HARPER\_ST Location: NW

ADA ID: RPRK211004122550 Ramp Type: Type 1 - Perpendicular Diagonal Initial Pass/Fail: Fail Overall Compliance: No Severity Score: 15

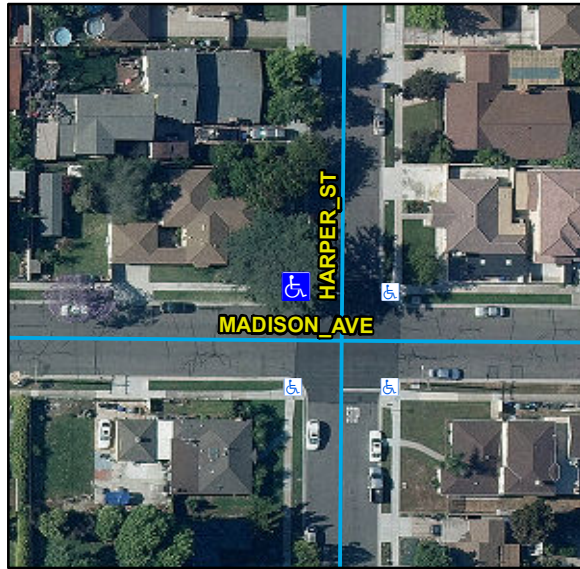
| Compliance | Description | Data | Compliance | Description | Data |
|---|---|---|---|---|---|
| No | Ramp Run Slope (%) | 11 | N/A | Flare Slope LT (%) | N/A |

**Remove & Replace Curb Ramp With Two New Directional Ramps or Equivalent.**

**R304.2.2, STD 1115**
