# Access Compliance Report Public Rights-of-Way (Curb Ramps)

Main Street: HAZARD\_AVE Cross Street: MONROE\_ST Location: NW

ADA ID: RPRK211004140825 Ramp Type: Type 1 - Perpendicular Diagonal Initial Pass/Fail: Fail Overall Compliance: No Severity Score: 16

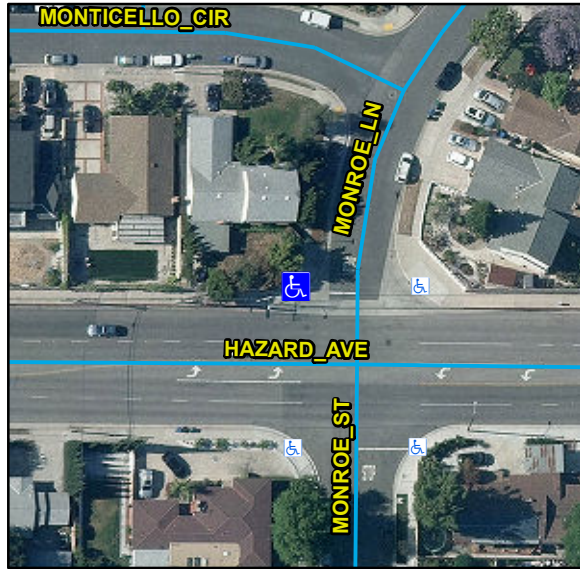
| Compliance | Description | Data | Compliance | Description | Data |
|---|---|---|---|---|---|
| No | Ramp Run Slope (%) | 11.9 | N/A | Flare Slope LT (%) | N/A |
| No | Ramp Cross Slope (%) | 2.4 | N/A | Flare Traversable LT | N/A |

Remove & Replace Curb Ramp With Two New Directional Ramps or Equivalent.

R304.2.2, R304.5.3, STD 1115
