# Access Compliance Report Public Rights-of-Way (Curb Ramps)

Main Street: MONROE\_ST Cross Street: HAZARD\_AVE Location: NE

ADA ID: RPRK211004141136 Ramp Type: Type 1 - Perpendicular Diagonal Initial Pass/Fail: Fail Overall Compliance: No Severity Score: 15

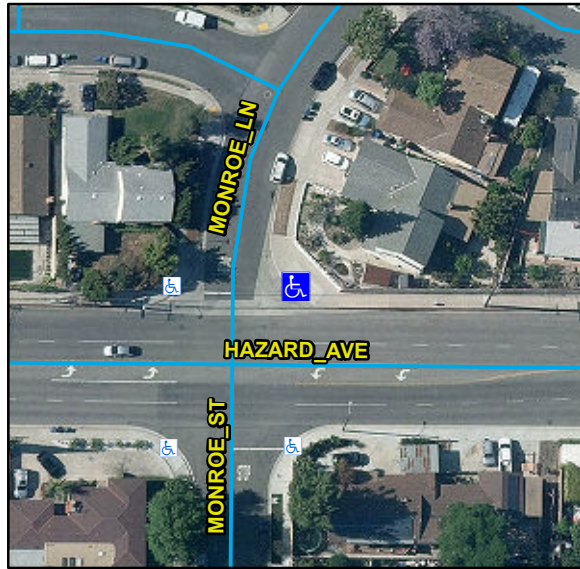
| Compliance | Description | Data | Compliance | Description | Data |
|---|---|---|---|---|---|
| No | Ramp Run Slope (%) | 10.2 | N/A | Flare Slope LT (%) | N/A |

**Remove & Replace Curb Ramp With Two New Directional Ramps or Equivalent.**

**R304.2.2, STD 1115**
