# Access Compliance Report Public Rights-of-Way (Curb Ramps)

Main Street: LEGION\_PL Cross Street: BEACH\_BLVD Location: SE

ADA ID: RPRK211004142858 Ramp Type: Type 1 - Perpendicular Diagonal Initial Pass/Fail: Fail Overall Compliance: No Severity Score: 30

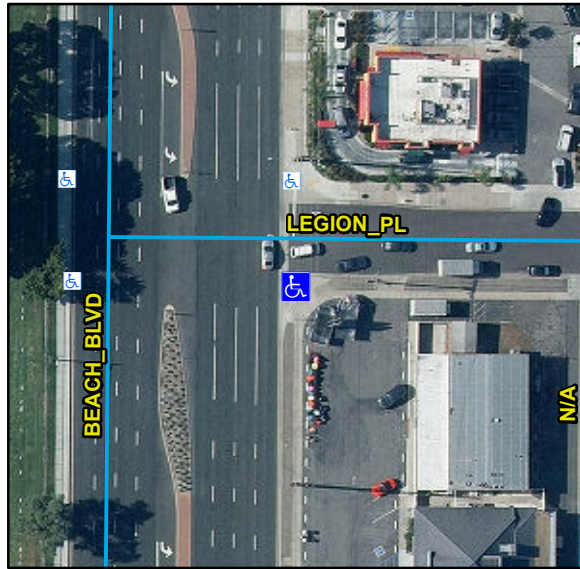
| Compliance | Description | Data | Compliance | Description | Data |
|---|---|---|---|---|---|
| No | Ramp Run Slope (%) | 13.3 | N/A | Flare Slope LT (%) | N/A |

Remove & Replace Curb Ramp With Two New Directional Ramps or Equivalent.
