# Access Compliance Report Public Rights-of-Way (Curb Ramps)

Main Street: HAZARD\_AVE Cross Street: HAZARD\_AVE Location: NE

ADA ID: RPRK211004152731 Ramp Type: Type 1 - Perpendicular Diagonal Initial Pass/Fail: Fail Overall Compliance: No Severity Score: 2

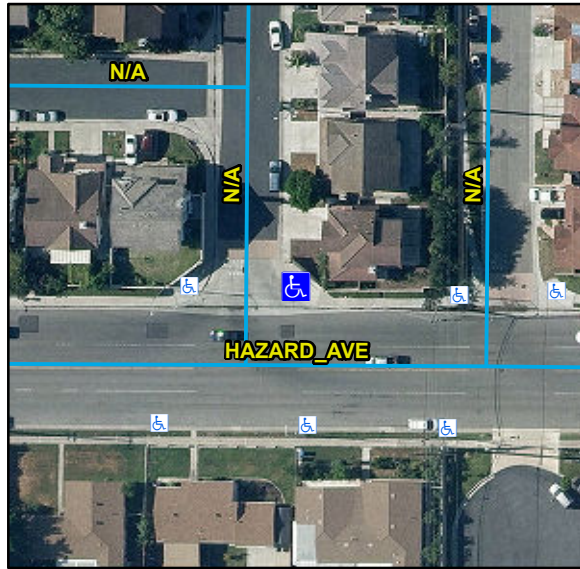
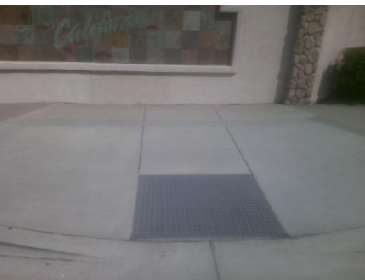
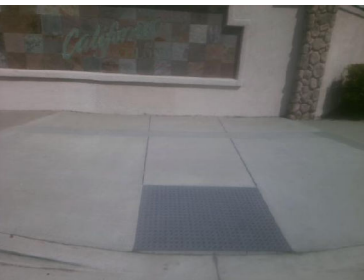
| Compliance | Description | Data | Compliance | Description | Data |
|---|---|---|---|---|---|
| No | Ramp Cross Slope (%) | 4.2 | N/A | Flare Traversable LT | N/A |

Remove & Replace Curb Ramp With Two New Directional Ramps or Equivalent.
