# Access Compliance Report Public Rights-of-Way (Curb Ramps)

Main Street: HAZARD\_AVE Cross Street: HAZARD\_AVE Location: NW

ADA ID: RPRK211004153018 Ramp Type: Type 1 - Perpendicular Diagonal Initial Pass/Fail: Fail Overall Compliance: No Severity Score: 2

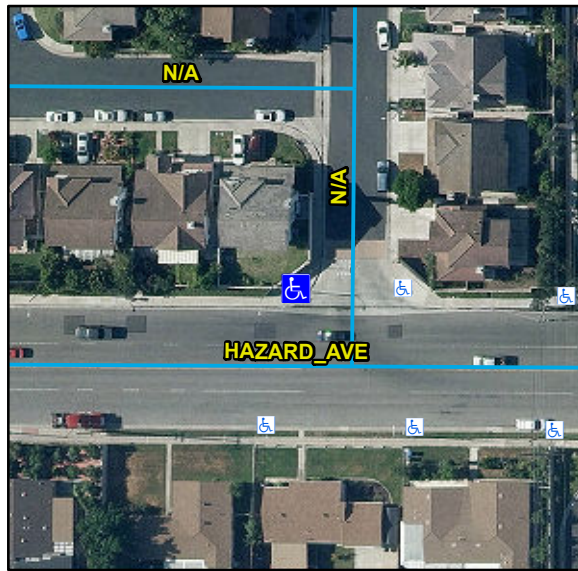
| Compliance | Description | Data | Compliance | Description | Data |
|---|---|---|---|---|---|
| No | Ramp Cross Slope (%) | 3.2 | N/A | Flare Traversable LT | N/A |

Remove & Replace Curb Ramp With Two New Directional Ramps or Equivalent.

R304.2.2, R304.5.3, STD 1115
