# Access Compliance Report

## Public Rights-of-Way

### (Curb Ramps)

Main Street: JACKSON\_ST Cross Street: BOLSA\_AVE Location: NE

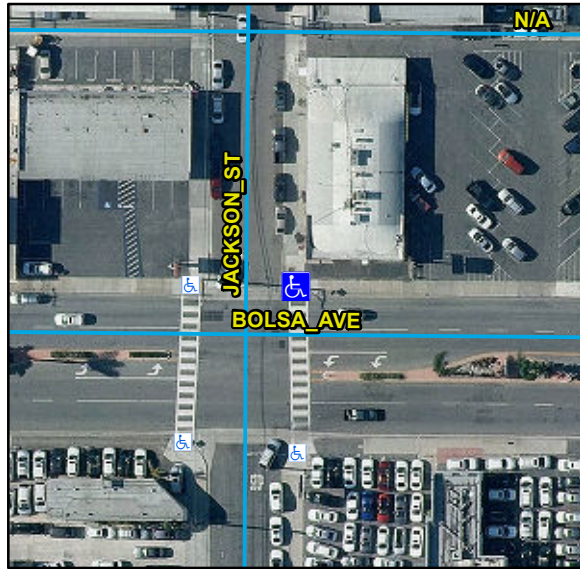
ADA ID: RPRK211004171047 Ramp Type: Type 1 - Perpendicular Diagonal Initial Pass/Fail: Fail Overall Compliance: No Severity Score: 35

| Compliance | Description | Data | Compliance | Description | Data |
|---|---|---|---|---|---|
| No | Ramp Width (in) | 36 | | | N/A |
| No | Ramp Run Slope (%) | 12.3 | N/A | Flare Slope LT (%) | N/A |
| No | Ramp Cross Slope (%) | 4.4 | N/A | Flare Traversable LT | N/A |

**Remove & Replace Curb Ramp With Two New Directional Ramps or Equivalent. Restripe Crosswalk.**
