# Access Compliance Report Public Rights-of-Way (Curb Ramps)

Main Street: JACKSON\_ST Cross Street: BOLSA\_AVE Location: SE

ADA ID: RPRK211004171638 Ramp Type: Type 1 - Perpendicular Diagonal Initial Pass/Fail: Fail Overall Compliance: No Severity Score: 19

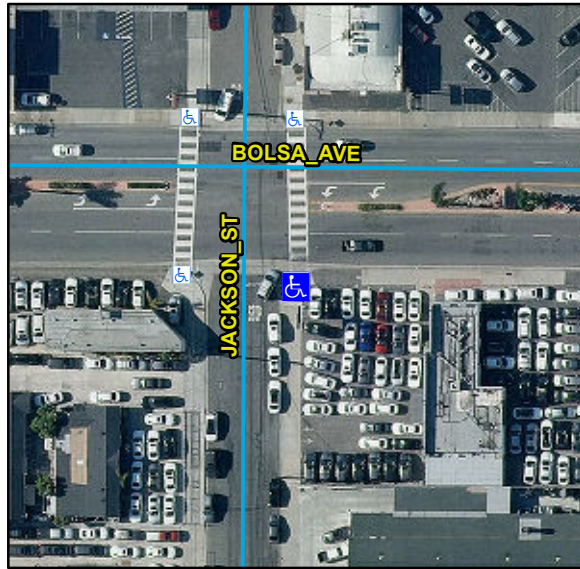
| Compliance | Description | Data | Compliance | Description | Data |
|---|---|---|---|---|---|
| No | Ramp Width (in) | 36 | | | N/A |
| No | Ramp Run Slope (%) | 10.4 | N/A | Flare Slope LT (%) | N/A |

Remove & Replace Curb Ramp With Two New Directional Ramps or Equivalent.
