# Access Compliance Report

## Public Rights-of-Way

### (Curb Ramps)

Main Street: ADAMS\_ST Cross Street: BOLSA\_AVE Location: NE

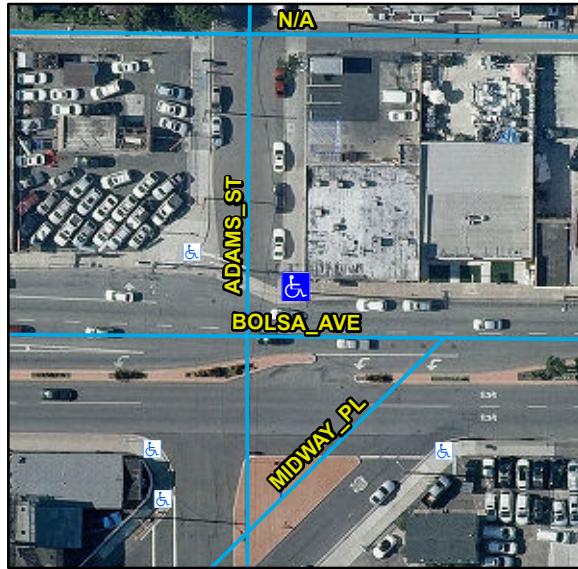
ADA ID: RPRK211004173551 Ramp Type: Type 1 - Perpendicular Diagonal Initial Pass/Fail: Fail Overall Compliance: No Severity Score: 34

| Compliance | Description | Data | Compliance | Description | Data |
|---|---|---|---|---|---|
| No | Ramp Width (in) | 36 | | | N/A |
| No | Ramp Run Slope (%) | 12.9 | N/A | Flare Slope LT (%) | N/A |

**Remove & Replace Curb Ramp With Two New Directional Ramps or Equivalent.**

R304.2.2, R304.5.1, STD 1115
