# Access Compliance Report Public Rights-of-Way (Curb Ramps)

Main Street: BOLSA\_AVE Cross Street: WILSON\_ST Location: NW

ADA ID: RPRK211004175550 Ramp Type: Type 1 - Perpendicular Diagonal Initial Pass/Fail: Fail Overall Compliance: No Severity Score: 5

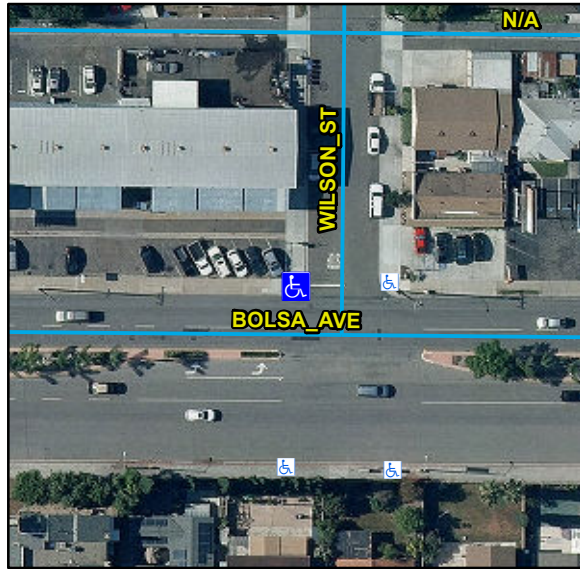
| Compliance | Description | Data | Compliance | Description | Data |
|---|---|---|---|---|---|
| No | Ramp Width (in) | 36 | | | N/A |
| No | Ramp Cross Slope (%) | 3.3 | N/A | Flare Traversable LT | N/A |

**Remove & Replace Curb Ramp With Two New Directional Ramps or Equivalent.**

**R304.2.2, R304.5.1, R304.5.3, STD 1115**
