# Access Compliance Report Public Rights-of-Way (Curb Ramps)

Main Street: WILSON\_ST Cross Street: BOLSA\_AVE Location: NE

ADA ID: RPRK211004180107 Ramp Type: Type 1 - Perpendicular Diagonal Initial Pass/Fail: Fail Overall Compliance: No Severity Score: 5

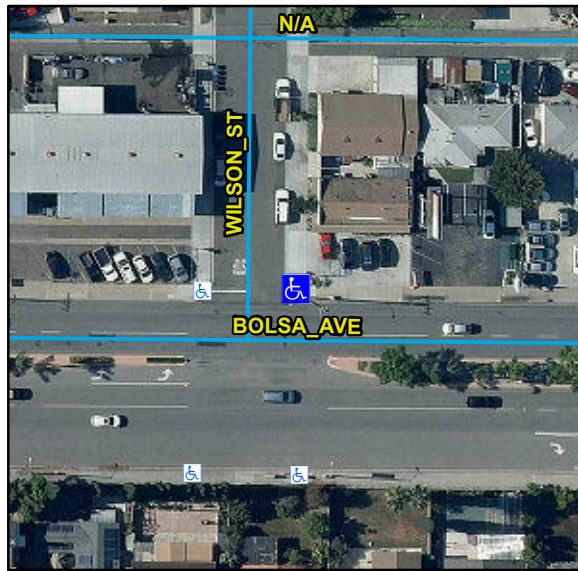
| Compliance | Description | Data | Compliance | Description | Data |
|---|---|---|---|---|---|
| No | Ramp Width (in) | 36 | | | N/A |
| N/A | Gutter Ponding | N/A | No | Curb Slope | 13.8 |

Remove & Replace Curb Ramp With Two New Directional Ramps or Equivalent.

R304.2.2, R304.5.1, STD 1115
