# Access Compliance Report Public Rights-of-Way (Curb Ramps)

Main Street: BOLSA\_AVE Cross Street: HARPER\_ST Location: NW

ADA ID: RPRK211004180928 Ramp Type: Type 1 - Perpendicular Diagonal Initial Pass/Fail: Fail Overall Compliance: No Severity Score: 5

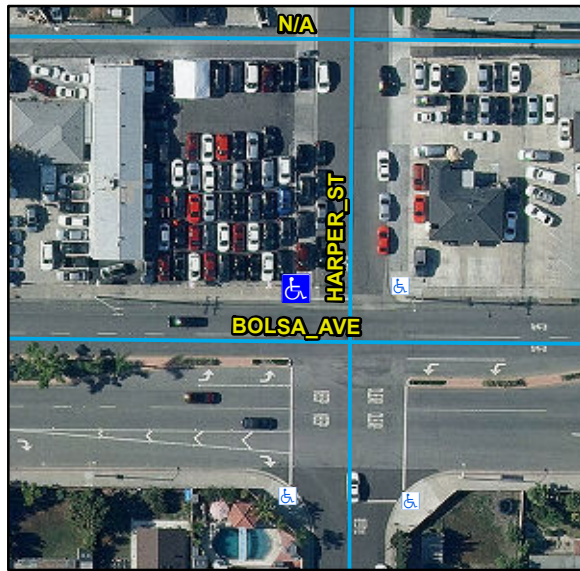
| Compliance | Description | Data | Compliance | Description | Data |
|---|---|---|---|---|---|
| No | Ramp Width (in) | 36 | | | N/A |
| No | Ramp Cross Slope (%) | 2.9 | N/A | Flare Traversable LT | N/A |

**Remove & Replace Curb Ramp With Two New Directional Ramps or Equivalent.**

**R304.5.1, R304.5.3, STD 1115**
