# Access Compliance Report Public Rights-of-Way (Curb Ramps)

Main Street: BOLSA\_AVE Cross Street: HARPER\_ST Location: SE

ADA ID: RPRK211004182000 Ramp Type: Type 1 - Perpendicular Diagonal Initial Pass/Fail: Fail Overall Compliance: No Severity Score: 19

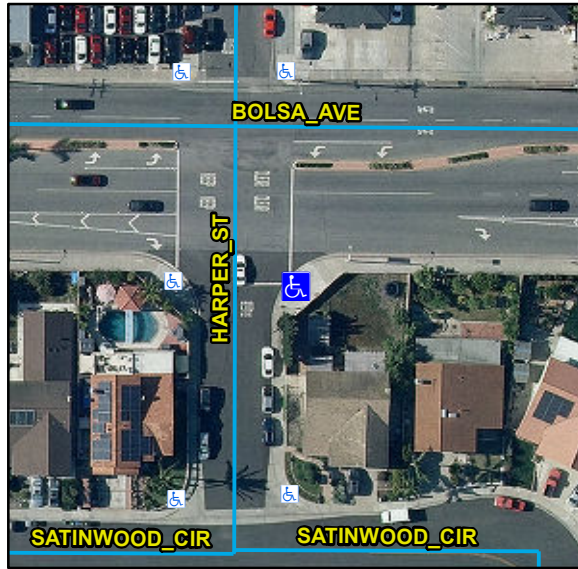
| Compliance | Description | Data | Compliance | Description | Data |
|---|---|---|---|---|---|
| No | Ramp Width (in) | 36 | | | N/A |
| No | Ramp Run Slope (%) | 10.4 | N/A | Flare Slope LT (%) | N/A |

Remove & Replace Curb Ramp With Two New Directional Ramps or Equivalent.

R304.2.2, R304.5.1, STD 1115
