# Access Compliance Report Public Rights-of-Way (Curb Ramps)

Main Street: HARPER\_ST Cross Street: BOLSA\_AVE Location: SW

ADA ID: RPRK211004182621 Ramp Type: Type 1 - Perpendicular Diagonal Initial Pass/Fail: Fail Overall Compliance: No Severity Score: 20

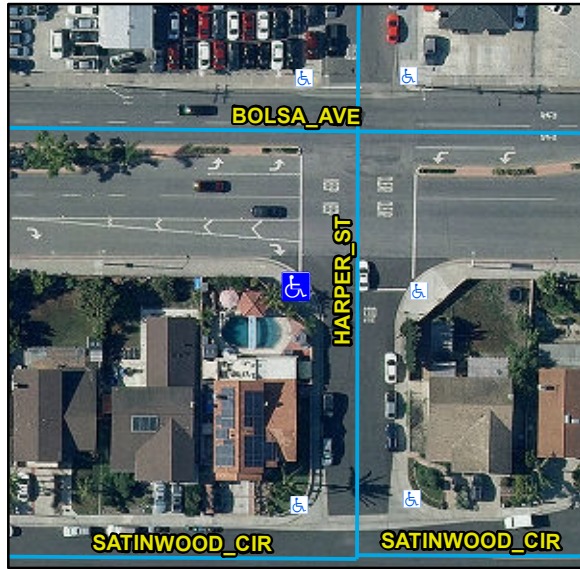
| Compliance | Description | Data | Compliance | Description | Data |
|---|---|---|---|---|---|
| No | Ramp Width (in) | 36 | | | N/A |
| No | Ramp Run Slope (%) | 10.5 | N/A | Flare Slope LT (%) | N/A |
| No | Ramp Cross Slope (%) | 3.5 | N/A | Flare Traversable LT | N/A |

Remove & Replace Curb Ramp With Two New Directional Ramps or Equivalent.

R304.2.2, R304.5.1, R304.5.3, STD 1115
